505 Davisville Avenue, Toronto, Ontario

## **SUMMARY INSPECTION REPORT**

## INSPECTION REPORT

PROPERTY: 505 Davisville Drive, Toronto, Ontario

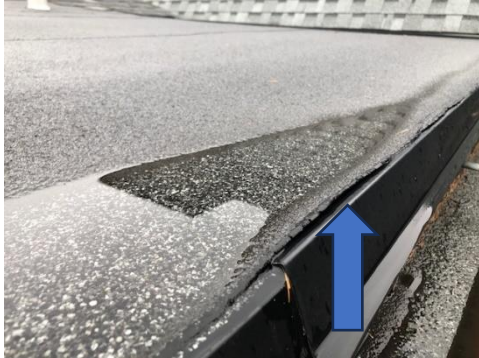
2.03F Modified bitumen membrane roof: This roofing installation typically involves a two-ply application with the seams sealed with either hot tar or heat-sealed with a propane torch. They are usually a reliable roofing system and typically last in excess of twenty years, depending on the product and the quality of the installation. The modified bitumen roofing membrane above the 2<sup>nd</sup> floor was resurfaced <10 years ago and is in good shape. The flat roof above the rear addition is older and is also in good condition.

*P: a seam on the south leading edge of the upper-level flat is not watertight and should be resealed with roof caulking to prevent seepage through the roof overhang below.*

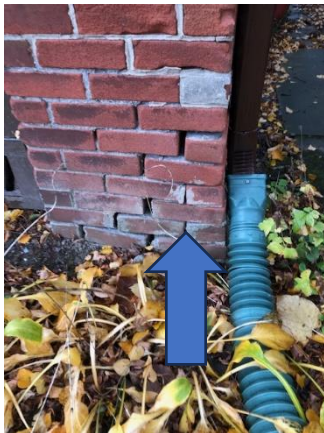
2.11B Front porch: The front porch structure shows no major defects. The horizontal roof beams are intact. The east masonry post has been rebuilt. The deck boards are sound and the rails are secure. The wooden steps are non-level. A handrail is present alongside the steps.

*P: repair loose bricks at the base of the west porch masonry column.*

*G: the wooden steps are no longer level and the rail post is deteriorated. The steps should ideally be rebuilt.*
